ENGINE PERFORMANCE OF ALLOY 73J TURBINE BLADES

CAST TO PREDETERMINED GRAIN SIZES

By James R. Johnston, Charles A. Gyorgak and John W. Weeton

July 2, 1954
Declassified May 16, 1958

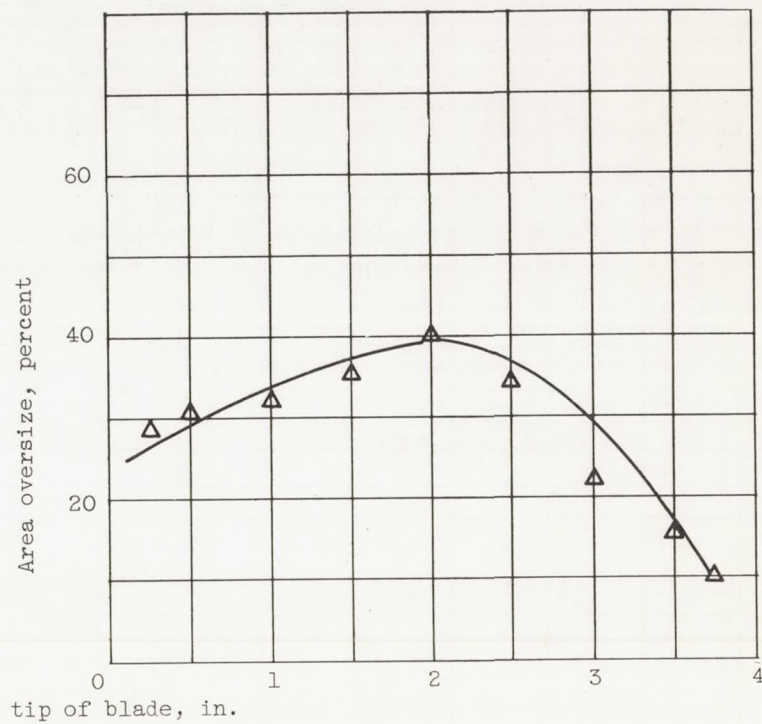
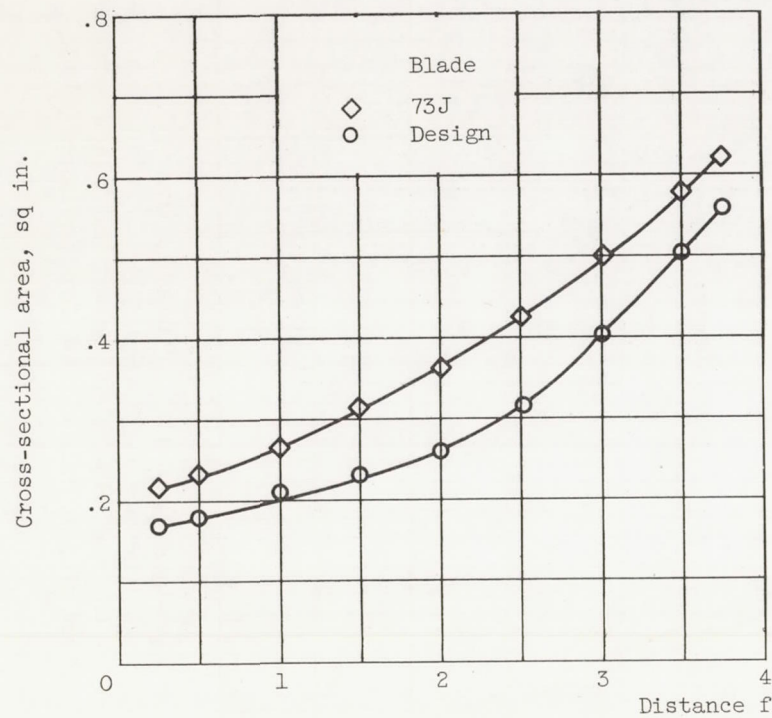
Dimensional checking of the blades showed them to be oversize. The differences in cross-sectional area from the desired blade design are shown in figure 1. These differences in area at any cross section in the blade would tend to reduce the stress at that section, but the resultant greater volume of material beyond this cross section would tend to increase the load that the area must carry. The net result is that the centrifugal stress, calculated by the method described in reference 7, was slightly higher than that of a standard-shaped blade (fig. 2). The increase in cross-sectional area, however, may tend to stiffen the blade and reduce vibratory stresses.

The blades used in this investigation were ordered to standard J33-9 blade specifications. However, the blades were cast oversize. The area oversize varied from 10.5 percent in certain locations of the airfoils to as much as 40.5 percent (fig. 1). At the same time that these 73J blades were obtained from the manufacturer, Stellite 21 blades cast to different grain sizes were also obtained. These blades, also oversize, were run in an engine in a similar test and the results have been reported in reference 4. The Stellite 21 blades did not exhibit improved life over standard-size blades and therefore it appears that the oversize effect in the 73J blades could not have accounted for the excellent performance of this alloy as blade material. To further substantiate this conclusion, three 73J blades were electromachined to an undersized condition, three were electromachined to standard size, and these six along with six oversized 73J blades were run in another turbine wheel with other alloys. Unfortunately all these blades were damaged by impact from fractured blade fragments of other alloys and had to be removed from the engine before actual failure had occurred. It may be somewhat significant, however, that two of the electromachined blades had run 74 hours, one 91 hours, two 188 hours, and one 213 hours before removal without indications of incipient fatigue failure. These data indicate that very early fatigue failure may not occur in blades of standard dimensions.

Figure 1. - Comparison of cross-sectional areas of 73J blade and designed blade.

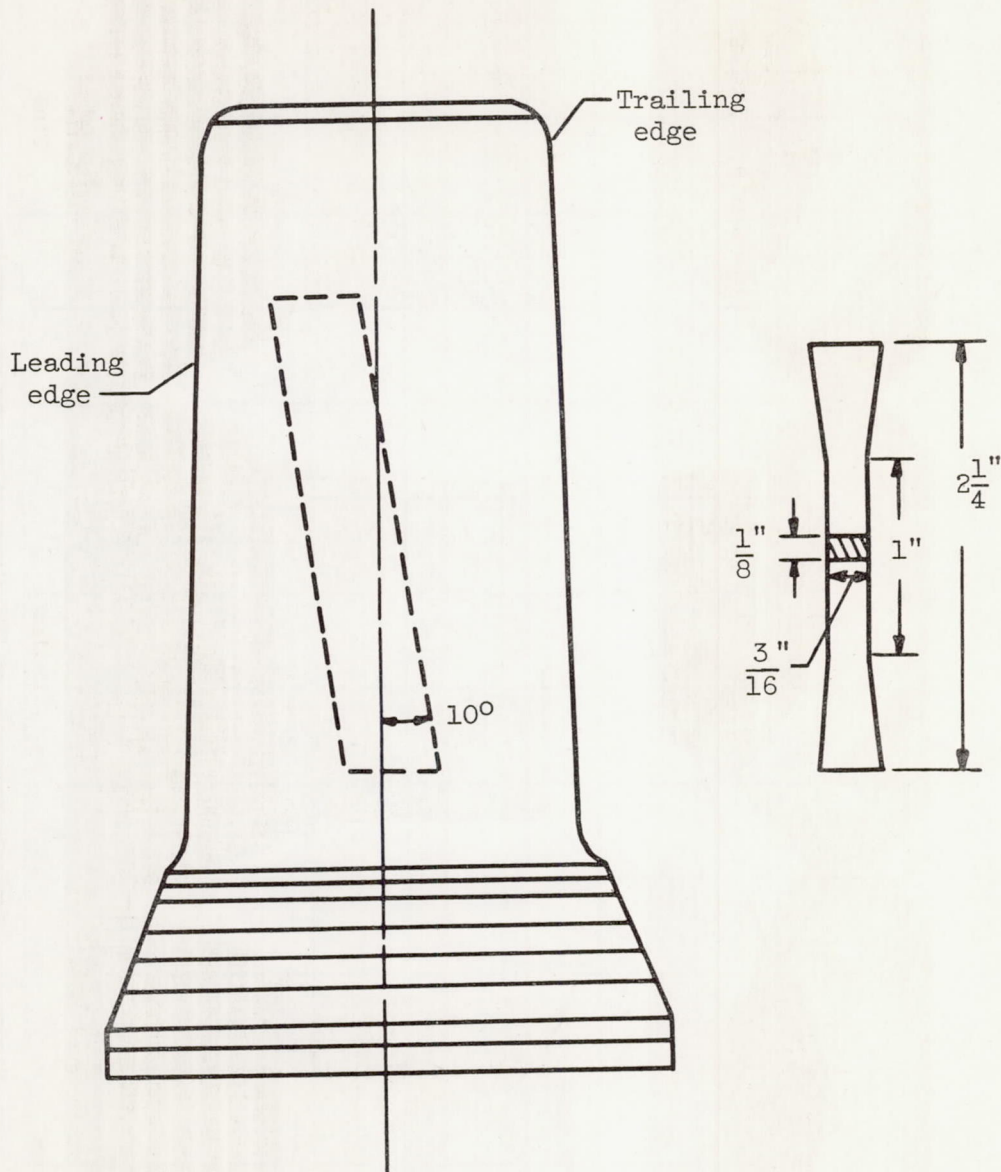
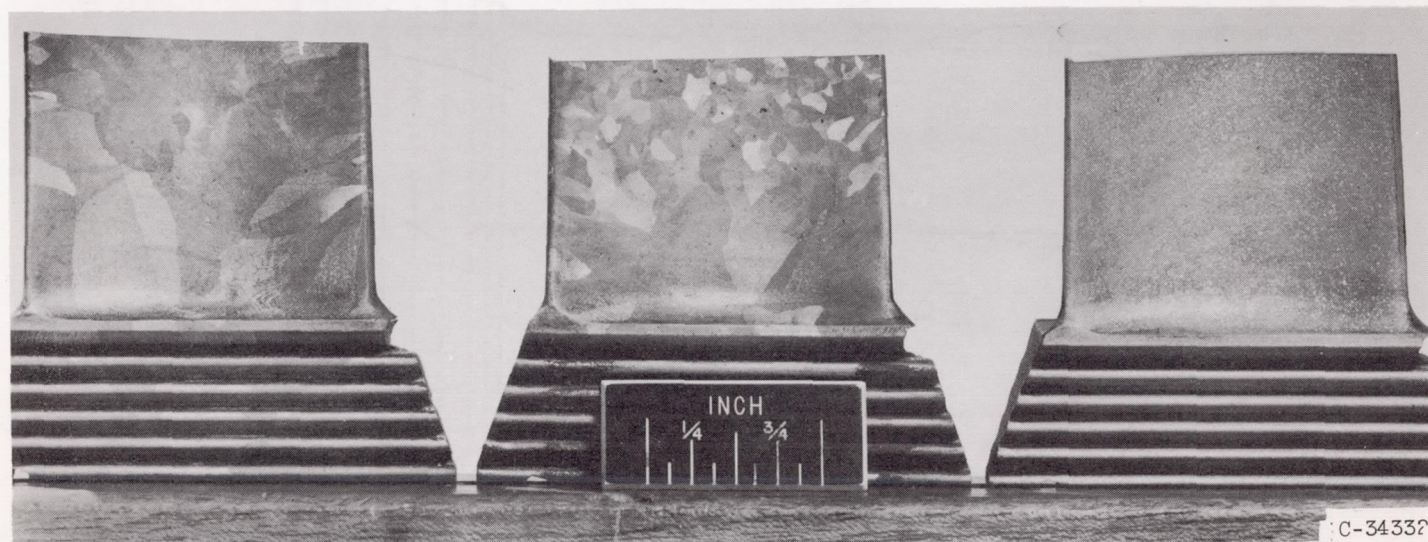
Figure 3. - Blade stress-rupture specimen and zone from which it was machined.

Stress-rupture specimens were taken from the airfoil section of the blade as shown in figure 3. The tests were made at the engine operating temperature and stress of 1500° F and 21,000 psi, respectively.

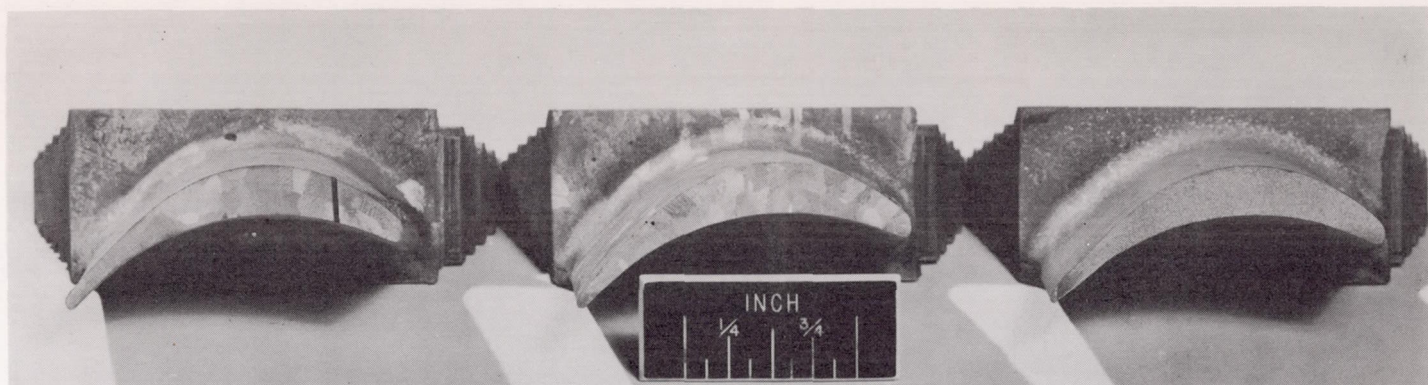
Figure 4. - Typical grain size of 73J blades after engine operation.

Figure 4 shows the grain size of the blades investigated. Macroscopic and microscopic examinations have shown the grain size present in the failure zone to be:

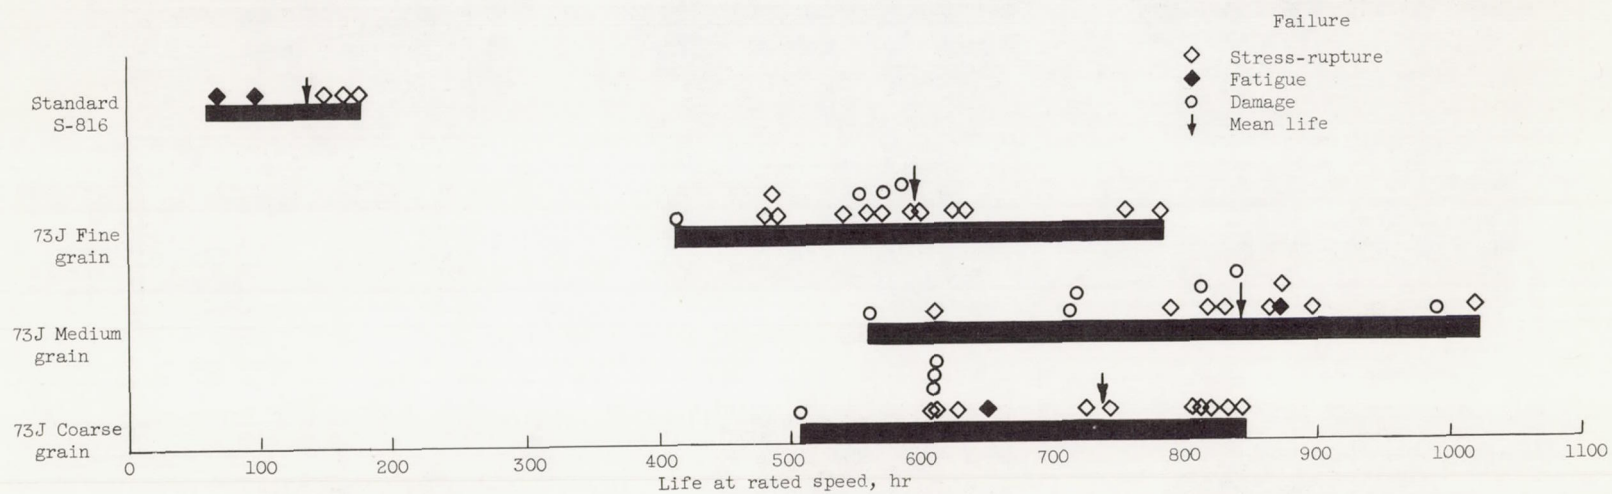
Figure 5. - Blade life of controlled grain-size 73J and S-816 turbine blades.

The engine life of 73J blades of three different grain-size groups and standard S-816 blades is plotted in figure 5. The engine life of all groups of 73J blades was far superior to that of the forged S-816 blades.

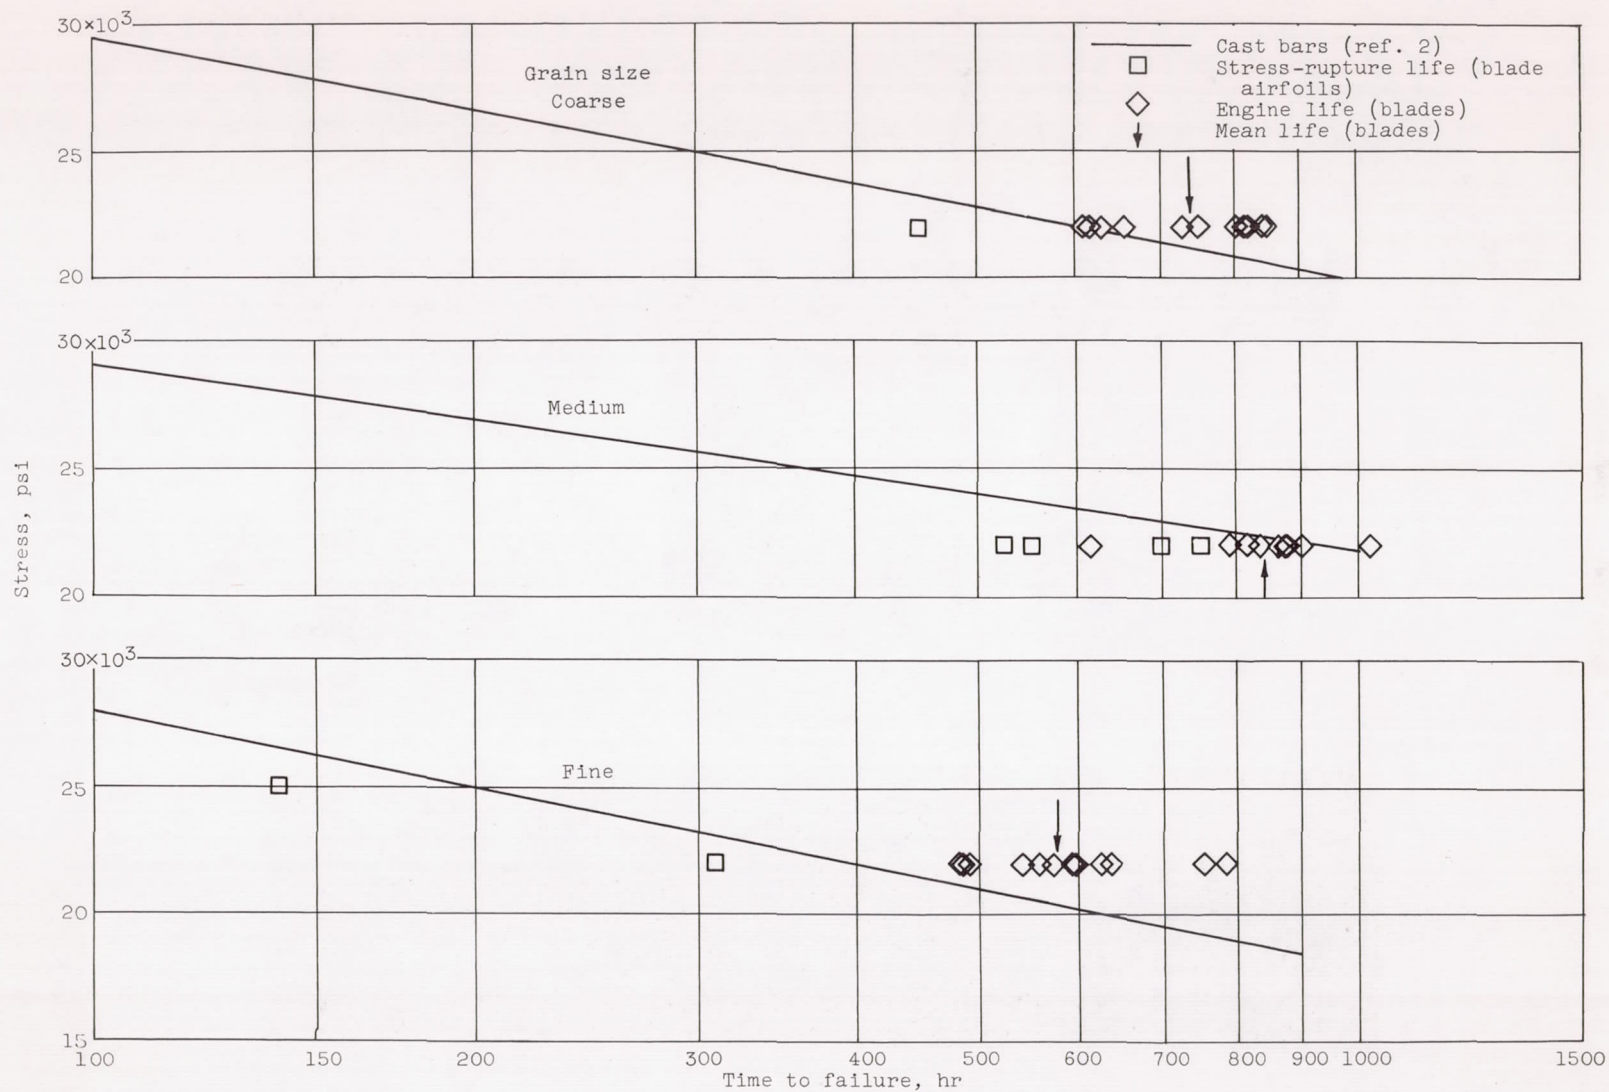
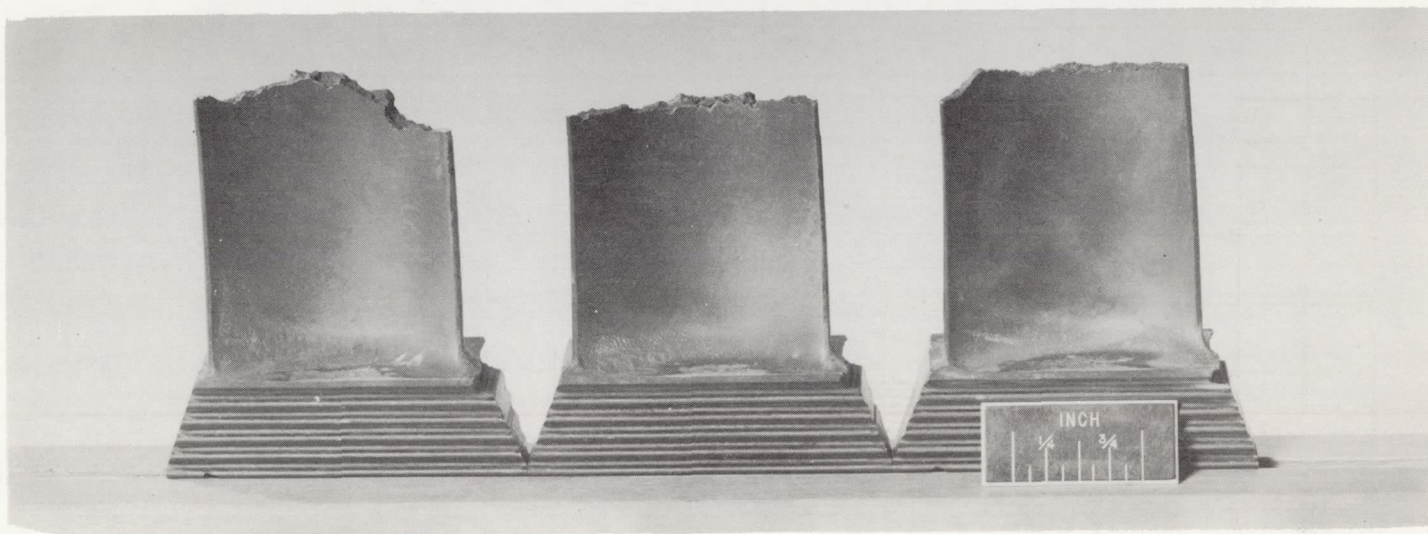
Figure 6. - Comparison of blade life, stress-rupture life of specimens cut from blade airfoils, and stress-rupture life of cast bars. Test temperature, 1500° F.

The engine operating data have been plotted in figure 6, along with stress-rupture data obtained from specimens cut from airfoils. For comparative purposes, curves on cast stress-rupture bars presented in reference 2 are also shown. In all cases, the data from blade specimens fell below the values obtained from cast bars. The engine operating life of the blades follow the trend mentioned before, that is, fine-grained blades have shorter life than the coarser-grained blades. The stress-rupture data for both the cast bars and specimens cut from airfoils also follow this trend. Thus it was shown that the blade life, the blade-airfoil stress-rupture life, and the cast-bar-stock stress-rupture life all follow a pattern of increasing life as the grain size changes from fine, to coarse, to medium.

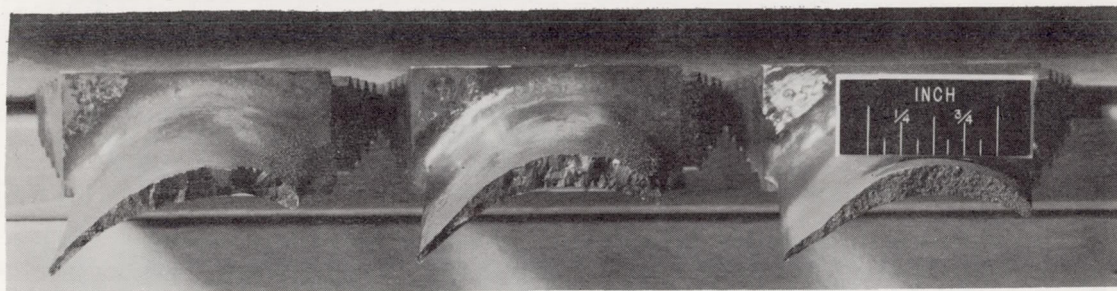
The locations of failure origin in the blades are listed in table I. The failures occurred primarily by a stress-rupture mechanism in the zone where the combination of stress and temperature is known to be most severe. All failures occurred in this zone, which is located 2 ± 0.34 inches above the base platform of the blade. Figure 7 shows that the mode of failure is typical of stress-rupture failures.

Figure 7. - Typical stress-rupture failures.

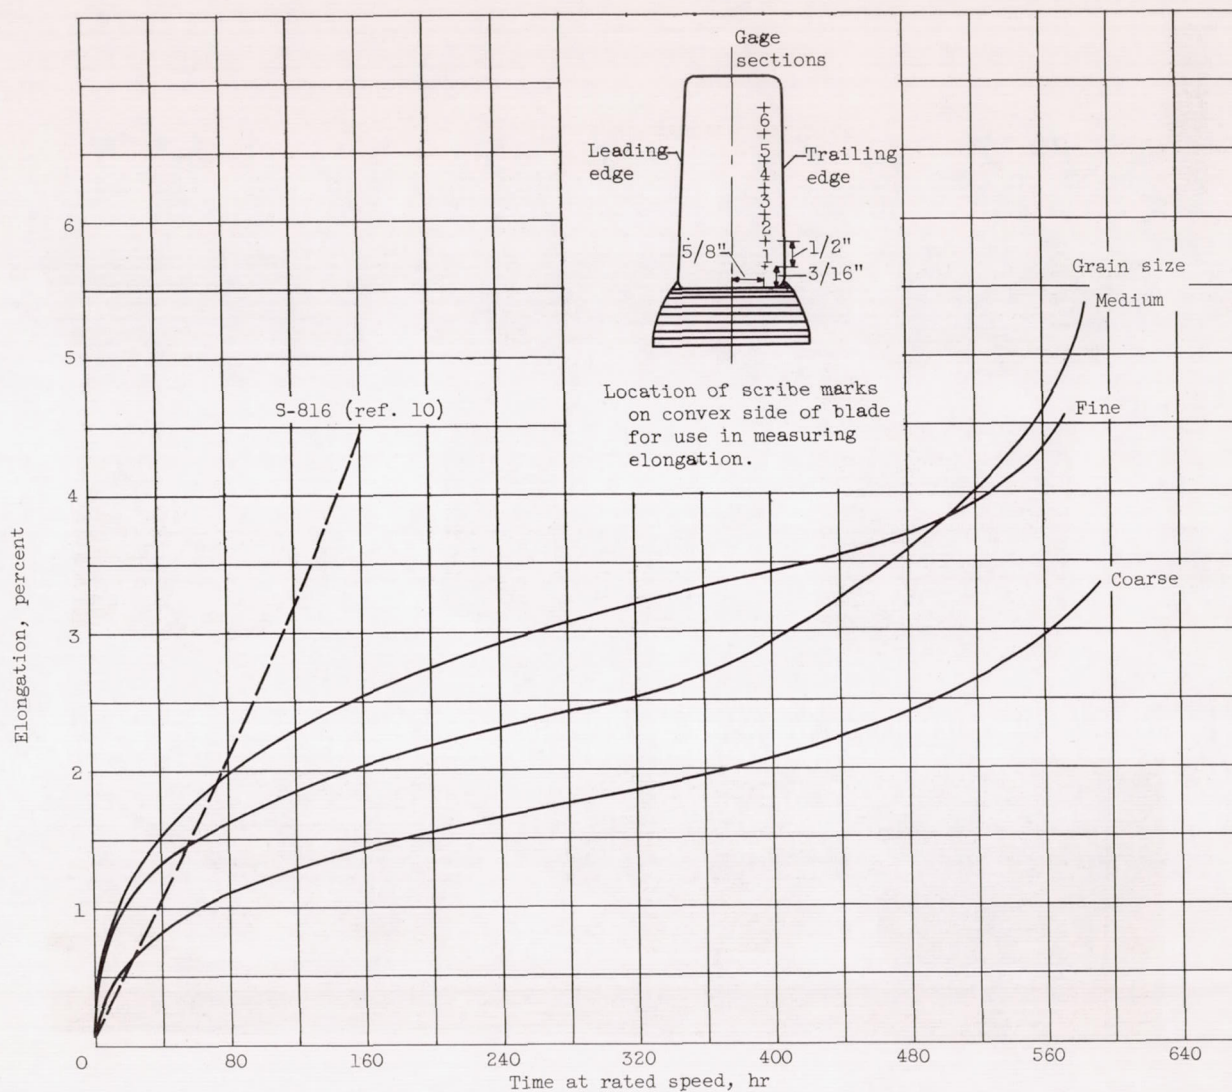
Figure 8. - Elongations of blade airfoils, average of positions 3 and 4.

The elongations occurring in the 1-inch gage length (zones 3 and 4) with the most severe combination of stress and temperature are plotted in figure 8. The total elongations in this zone, where the stress is approximately 21,000 psi at 1500° F, are as follows:

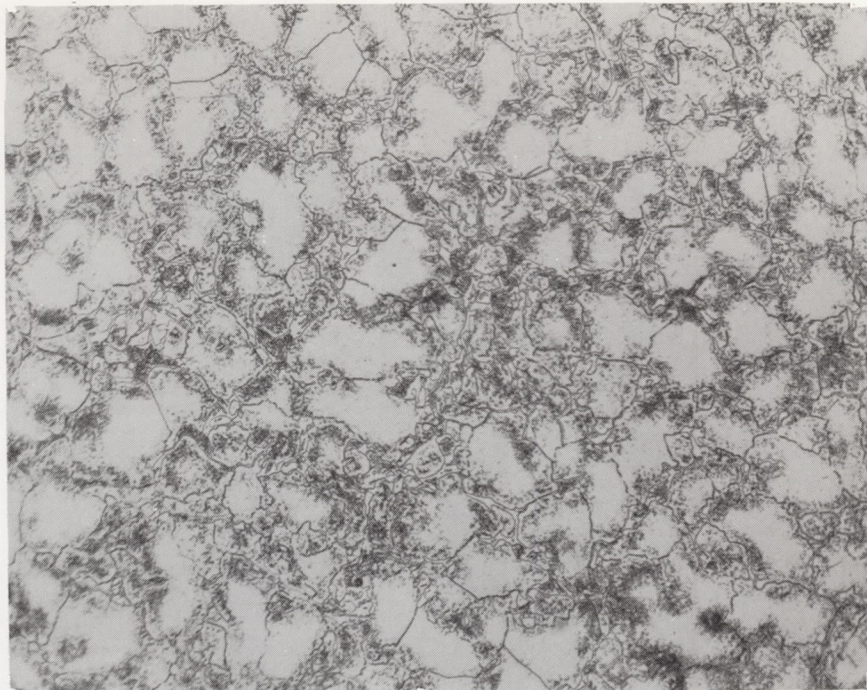
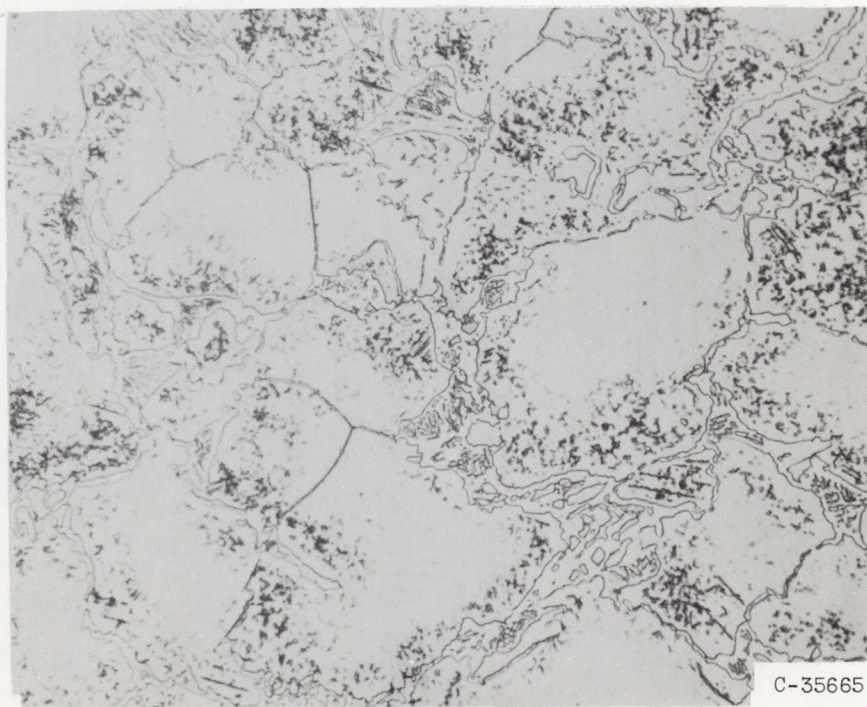
(a) 483.9 Hours.

Photomicrographs of first and last failures of fine-, medium-, and coarse-grained blades are shown in figures 9 to 11. The grain size of the fine-grained blades was determined by use of the metalloscope because the fineness of the grains permitted a large number to be present in the field of view. However, in the case of both the medium- and coarse-grained blades, the interdendritic networks and precipitates made it difficult to detect the true grain boundaries. The only way grains could be separated from each other in many areas was by the change in orientation of the interdendritic carbide networks from grain to grain. It was difficult to observe significant microstructural differences between first and last blade failures since greater differences frequently were found within a given blade. Coring of the cast structure and an anisotropic resistance to etching solutions probably obscured any differences in precipitation with time at temperature.

Figure 9. - Fine-grained 73J alloy operated at rated speed.
Electrolytically etched in 5-percent aqua regia.

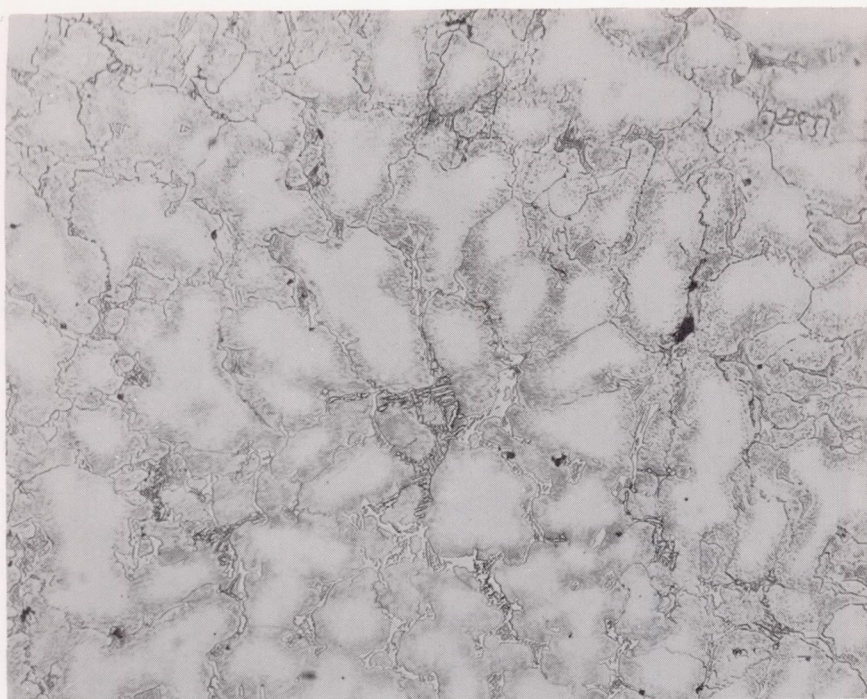
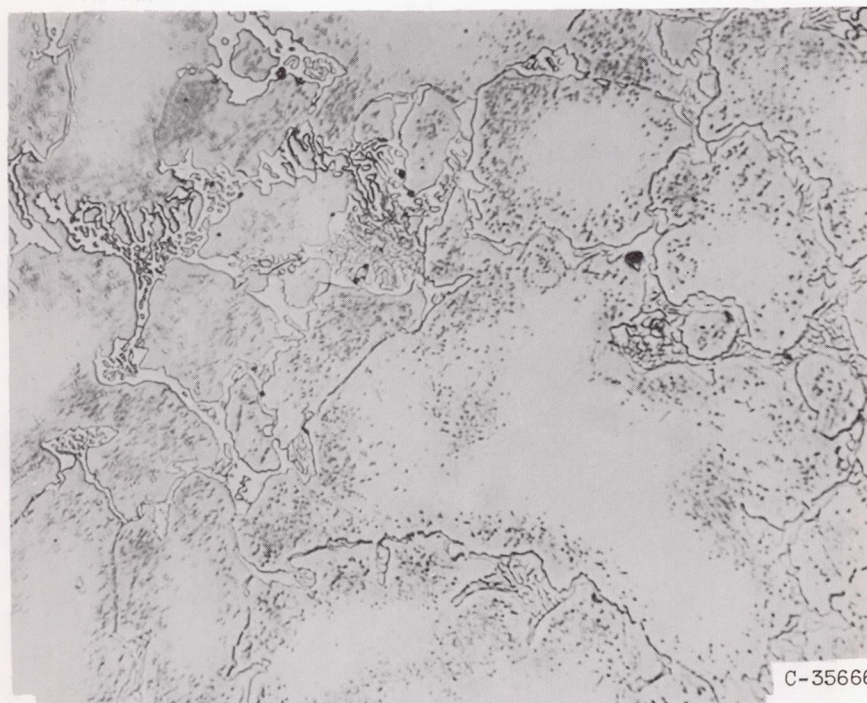
(b) 785.3 Hours.

Figure 9. - Concluded. Fine-grained 73J alloy operated at rated speed.
Electrolytically etched in 5-percent aqua regia.

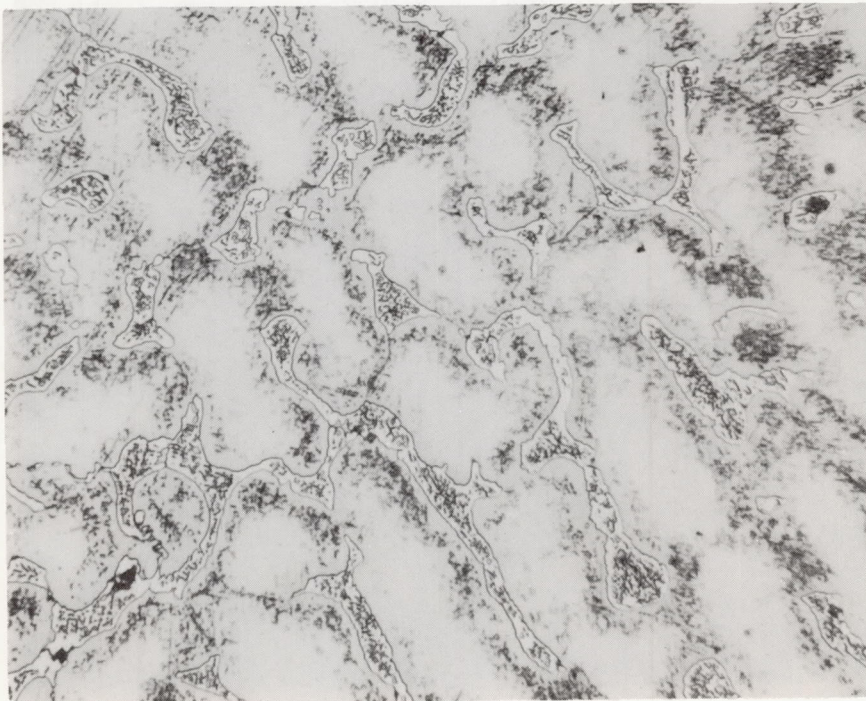
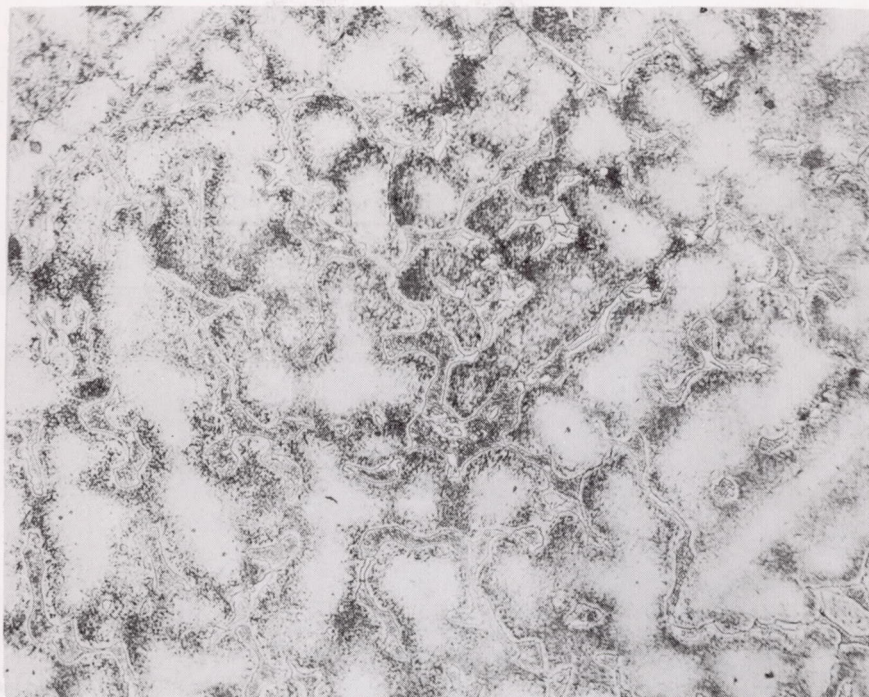
(a) 609.2 Hours.

Figure 11. - Coarse-grained 73J alloy operated at rated speed.
Electrolytically etched in 5-percent aqua regia.

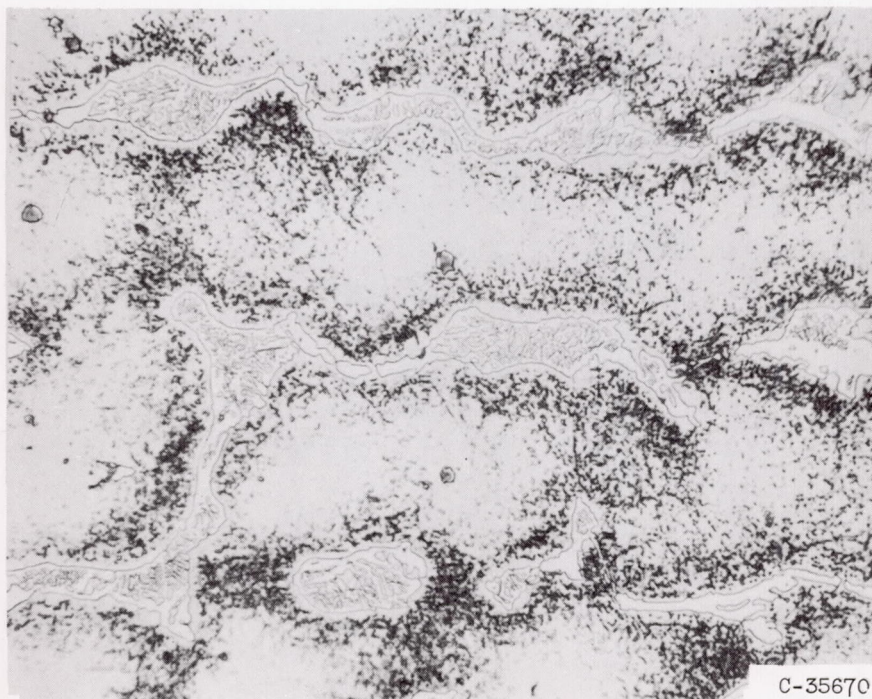
(b) 844.6 Hours.

Figure 11. - Concluded. Coarse-grained 73J alloy operated at rated speed. Electrolytically etched in 5-percent aqua regia.

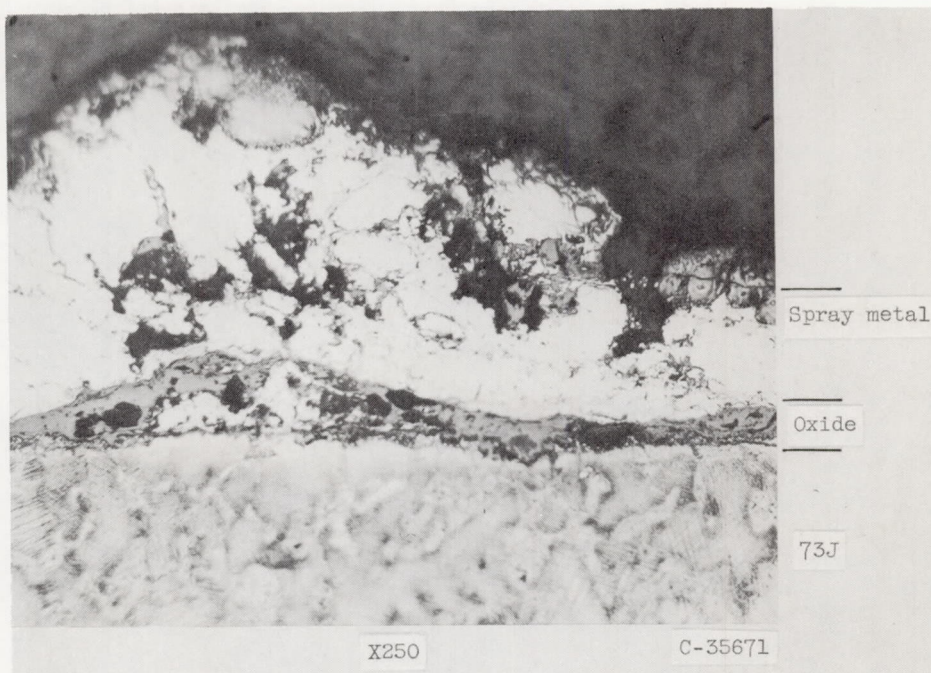
After 534 hours of rated speed operation the engine caught fire. An aluminum casting was melted, and the leading edges of the blades were sprayed. A typical sprayed area is shown in figure 12. It may be observed that the sprayed alloy adhered to the oxide coating on the blade surface and no alloying or metal-to-metal contact of the aluminum to the 73J was detected. Therefore, it was concluded that the presence of the sprayed metal on the blades did not affect the operating life of the 73J alloy.

Figure 12. - Aluminum deposited on convex edge of blade as result of engine fire. Electrolytically etched in 5-percent aqua regia.

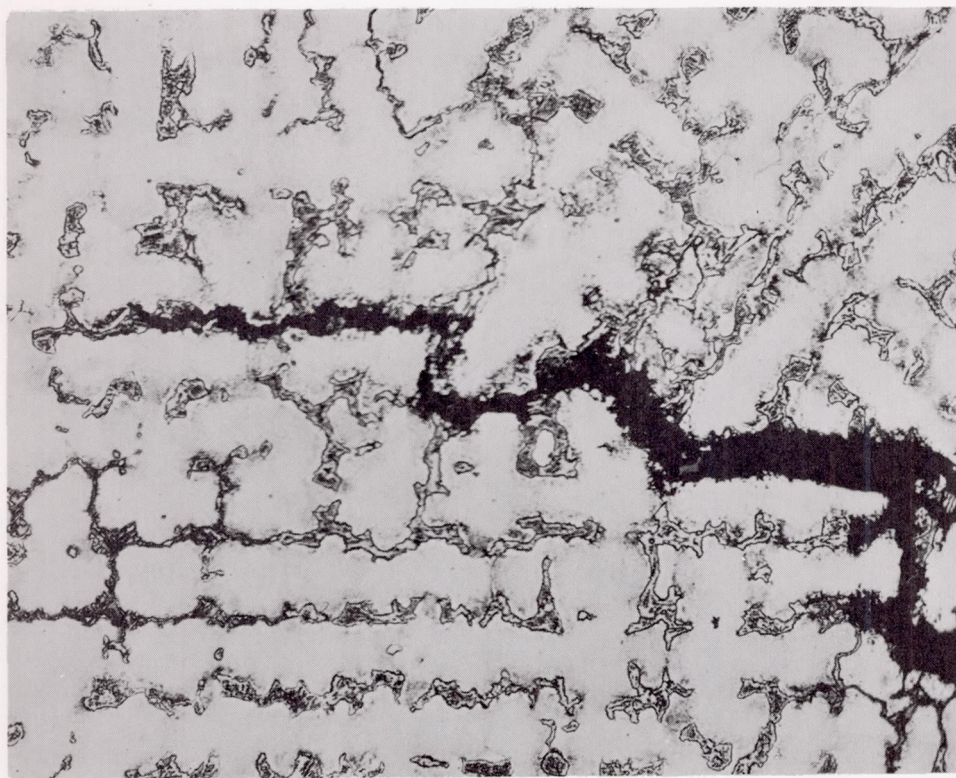
With the exception of the two fatigue failures, the remaining true failures occurred by the stress-rupture mechanism. Figure 13 shows the typical stress-rupture crack. The failure propagation proceeded along grain boundaries or interdendritic carbide paths, or both. It was difficult to differentiate between the two.

Figure 13. - Typical stress-rupture crack in 73J alloy blade.
Electrolytically etched in 10-percent aqueous HCl.
